Flight Motor Set 360L006 (STS-34) Final Report

Volume I - System Overview

February 1990

Thiokol CORPORATION
SPACE OPERATIONS

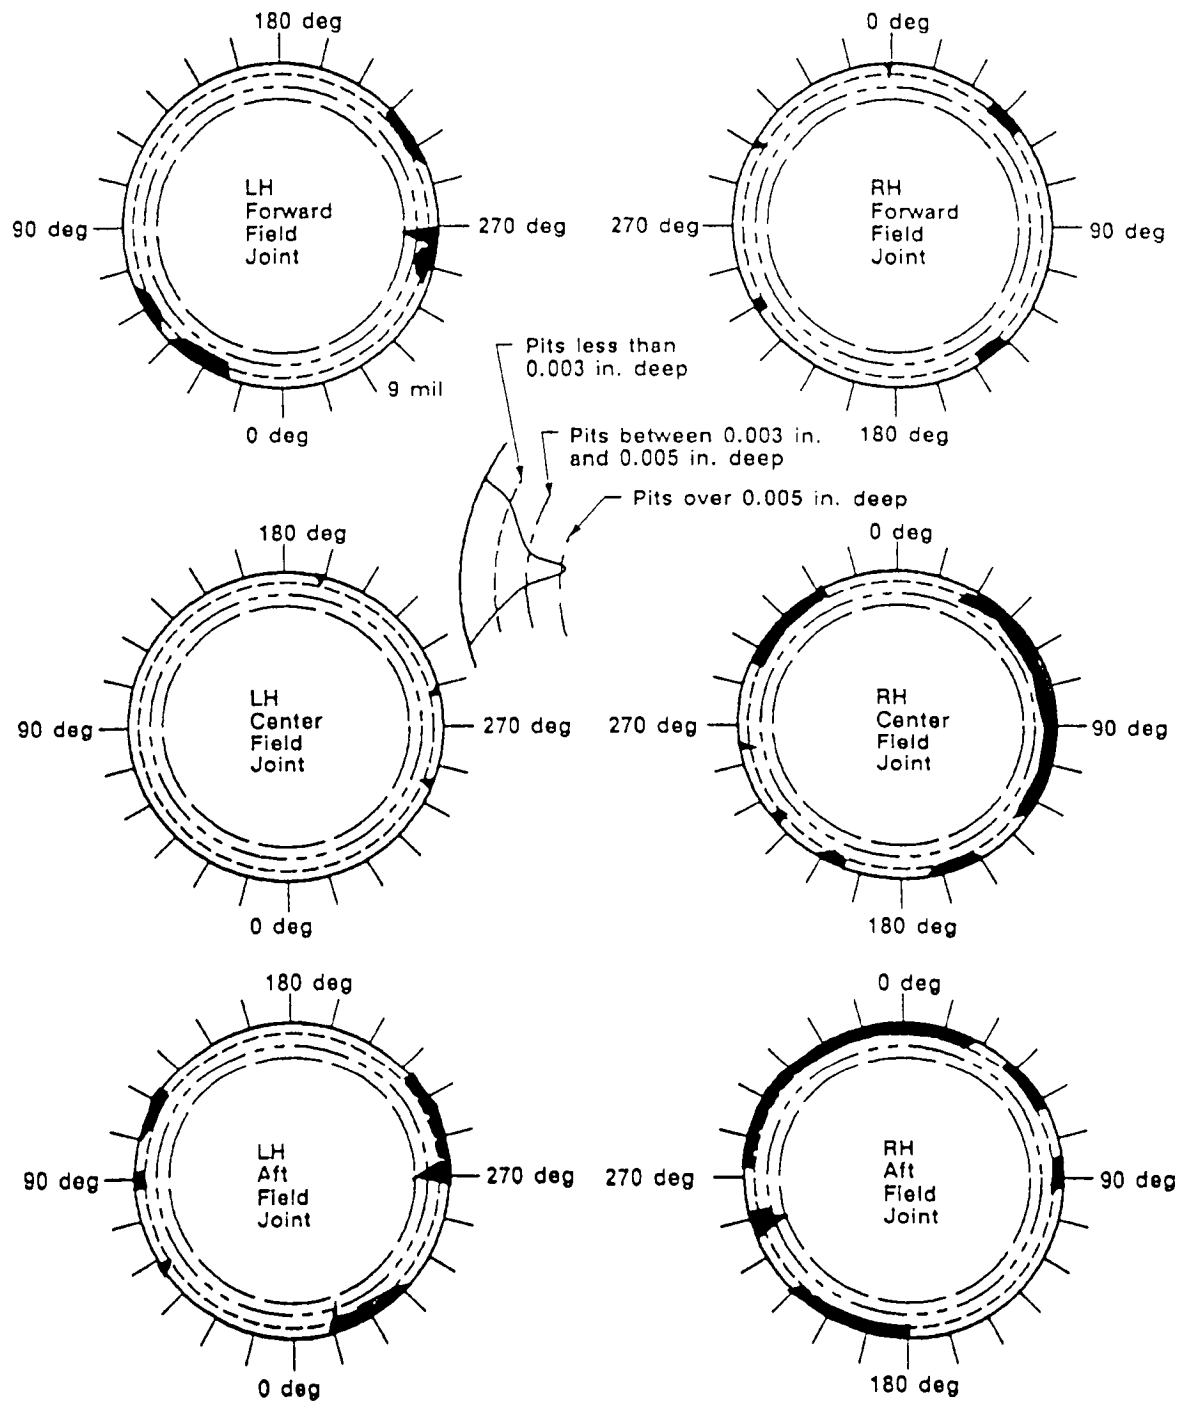
Figure 4-123. Overall Field Joint Fretting Observations

3.1.9.2 Case. The case field joint surface conditions were as expected. Field joint fretting on this flight ranged from extremely light on most of the joints to locally heavy on one joint. The fretting was worst on both center field joints with the RH aft joint having the heaviest.
